ASBESTOS SURVEY FOR FORT POINT U.S. COAST GUARD STATION

Presidio of San Francisco

September 1991

The Presidio of San Francisco
Phase II Environmental Study

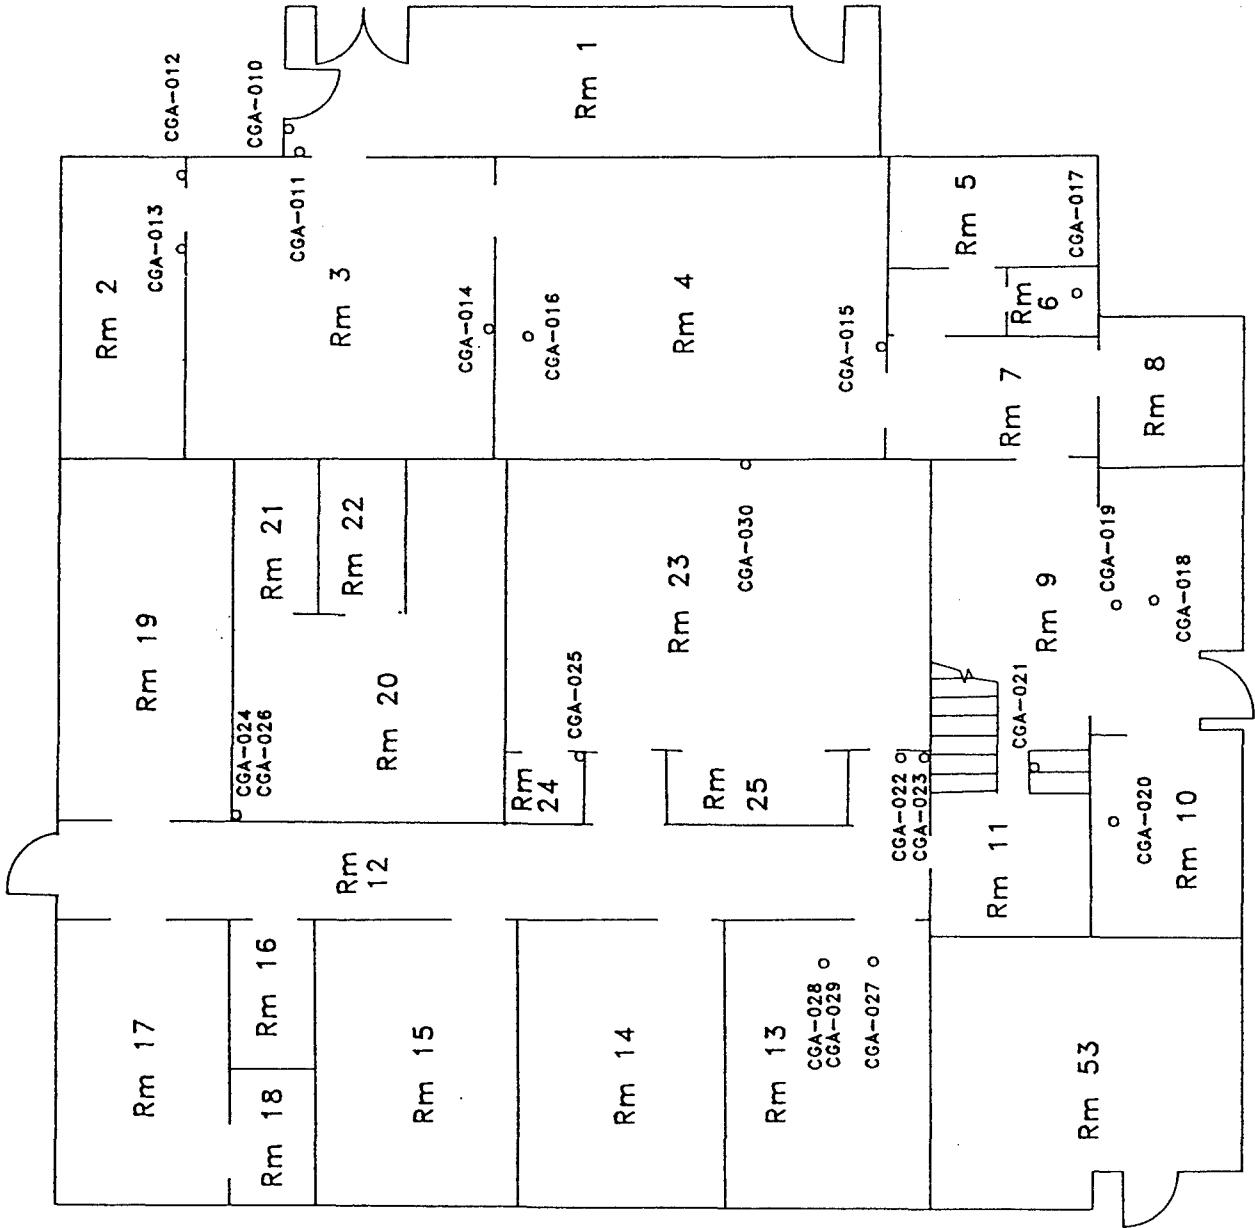
FLOOR PLAN & SAMPLE LOCATIONS
BLDG 991, FIRST FLOOR
FT. POINT U.S. COAST GUARD STATION
ASBESTOS SURVEY

One room in Building 991 contains 80 sq ft of linoleum floor material which contains 20-25 percent chrysotile asbestos. A work surface in Building 995 was covered with linoleum containing 1-5 percent chrysotile asbestos. Another work surface in Building 998 was covered with floor tiles also containing 1-5 percent chrysotile asbestos.
